# DISTAL MIGRATION OF THE RODS OF A CONSTRAINED POLYAXIAL PEDICLE SCREW SYSTEM

## ABSTRACT

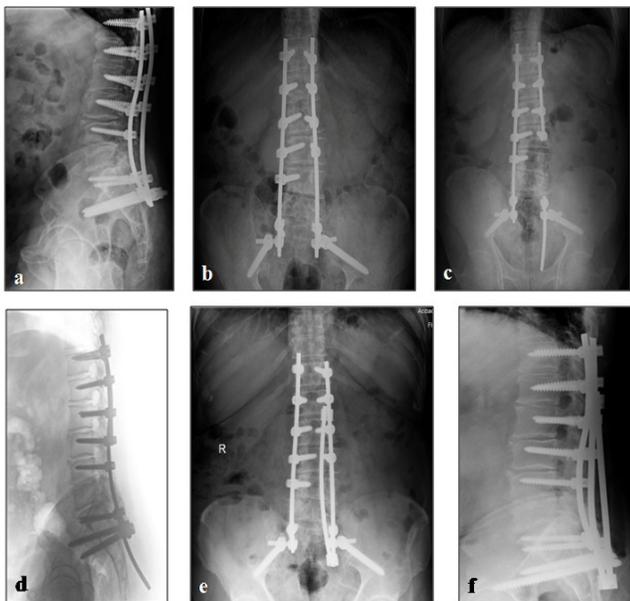
follow-up, lumbar-sacral radiographs revealed a broken left rod now lodged at the gluteal area due to caudal migration (Figure 1c, d). On further questioning, the patient reported some mild aching pain over his left buttock area especially with sitting, but denied any recent strenuous activity. There was no evidence of fusion yet at the instrumented levels. He subsequently underwent a revision surgery of his broken left rod with an additional bypass rod at the left side (Figure 1e, f). Intra-operatively, all the screw caps on the left side were loose. They appeared to be well centered but had backed off by one or two turns allowing the rod to slide down. The screws on the right side were tight. There was no evidence of infection or metallosis. Swabs for cultures were taken and all came back negative for infection.

**Figure 1.** Early post-operative X-ray, AP (a) and lateral view (b), a repeat X-ray at three months AP (c) and lateral (d) views showing a caudally migrated left rod. X-rays after revision surgery, AP (e) and lateral (f) views

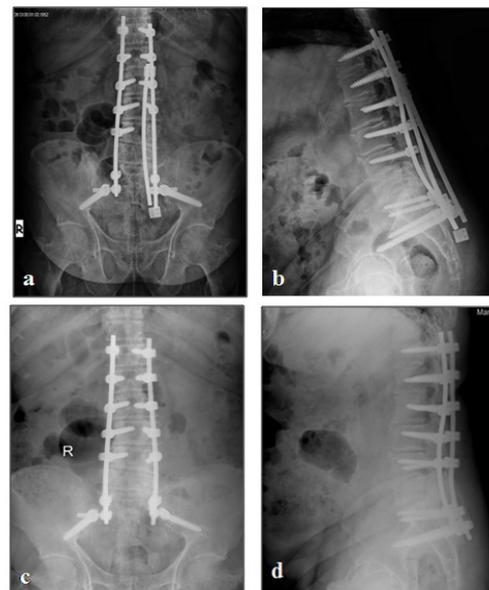
Twelve months after his second operation, “Case 1” presented to his local medical facility again complaining of left gluteal swelling and redness. According to accompanying notes, there was no evidence for local infection or gluteal abscess. Radiographs taken revealed a left sided distal domino failure and had caudally migrated and lodged at his left gluteal area (Figure 2a, b). Similarly, there was no history of recent trauma or strenuous activity. A third operation was subsequently performed for rod and screws exchange with another spinal instrumentation system (CD Horizon Engage 6.35 Spinal System, Medtronic, Minneapolis, MN USA) (Figure 2c, d). Intra-operative findings were strikingly similar to his previous surgery. Right rod was intact, screw caps on the left sided were well centered but had backed off one or two turns. There was no evidence of

**Figure 2.** One year after post revision surgery showing caudally migrated domino AP (a) and Lateral (b) X-rays views. Rod and screws exchange with another spinal instrumentation system AP (c) and Lateral (d) X-rays views

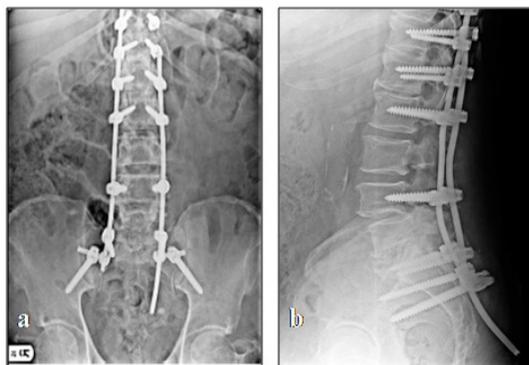
A 72-year-old male, who had a background history of L1-3 decompression and instrumented fusion for degenerative spinal stenosis performed at another institution 5 years before presenting to our center, was admitted. He had further comorbidities of diabetes mellitus for 32 years, fungal osteomyelitis of the maxilla (treated) and a BMI of 34.6. He presented with the recurrence of low back symptoms and was diagnosed as having further multi-level degenerative spinal stenosis and sagittal imbalance. Similar to the first patient, decompression as well as long instrumented fusion (using local iliac crest bone) from T9 to ileum with partial restoration of lumbar lordosis was performed. Two 6.0 mm titanium rods and multi-level titanium polyaxial screws of the same instrumentation system as case 1 were used for fixation (Xia Titanium Spinal System, Stryker Spine, Allendale, NJ, USA). His immediate post-operative period was unremarkable. Twelve months later, the patient presented back to our institution complaining of left gluteal pain and swelling. He denied any recent strenuous activity. Further evaluation and radiographs revealed a loose left rod that had migrated caudally to the gluteal area similar to the first patient (Figure 3a,b). The left rod was revised and intra-operative findings revealed loose caps on the left side (seven in total). The caps were well centered but had backed off. There were no signs of infection or metallosis noted and culture swabs were negative. His further follow-

**Figure 3.** Post-operative X-rays AP (a) and Lateral (b) subsequent sequential failure of fixation with rod migration.
